# **Andrew Rural Academy**

## **Capital Plan**

**2026-2029**

# Facility Condition Assessment (FCA) Report

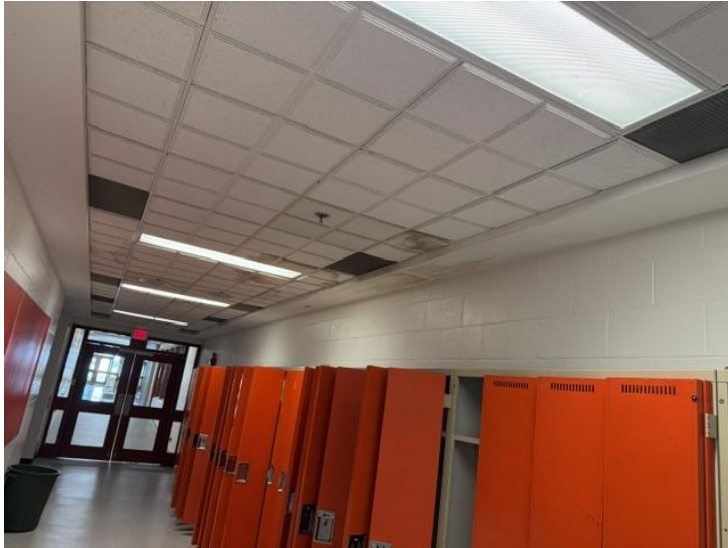
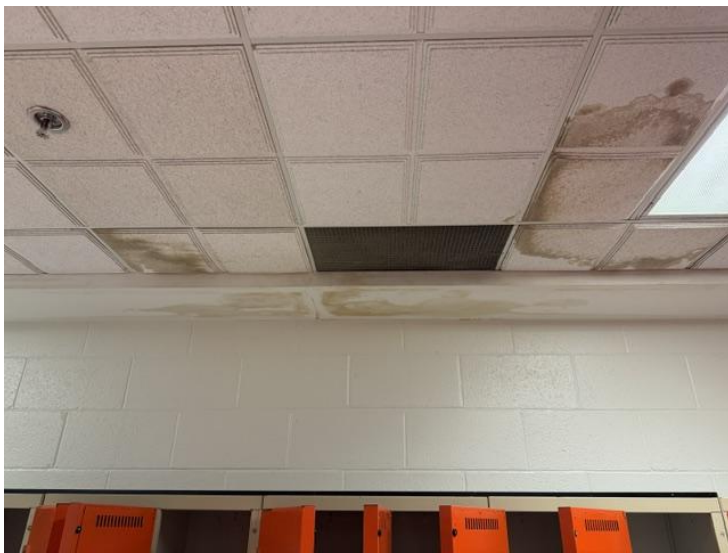
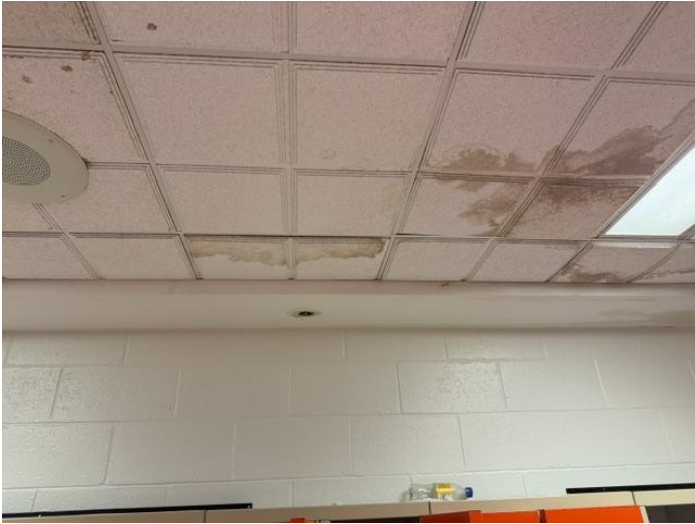
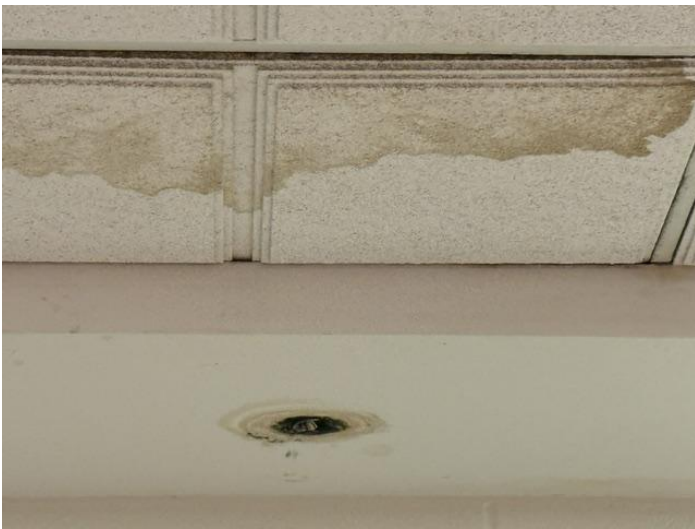
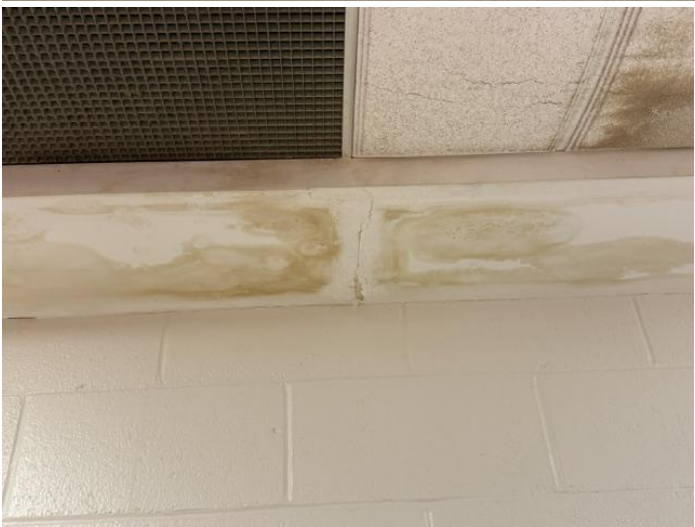
Corridor between Classrooms 141 and Home Ec room:

- Air Exchange Motor replacement \$3,000
- Roof repair; leaking portion over central hallway and Foods lab (warranty issue) \$150,000 minimum
- Roof repair; ice damming over link between daycare and village office causing significant interior damage >\$20,000...substructural analysis required
- Replacement of air filters in air exchange units \$2000
- Glycol tank replacement and refilling \$1500
- Upgrades to plumbing lines as required to prevent current repeated backups \$TBD

**Photos of interior damage due to roof failure:**

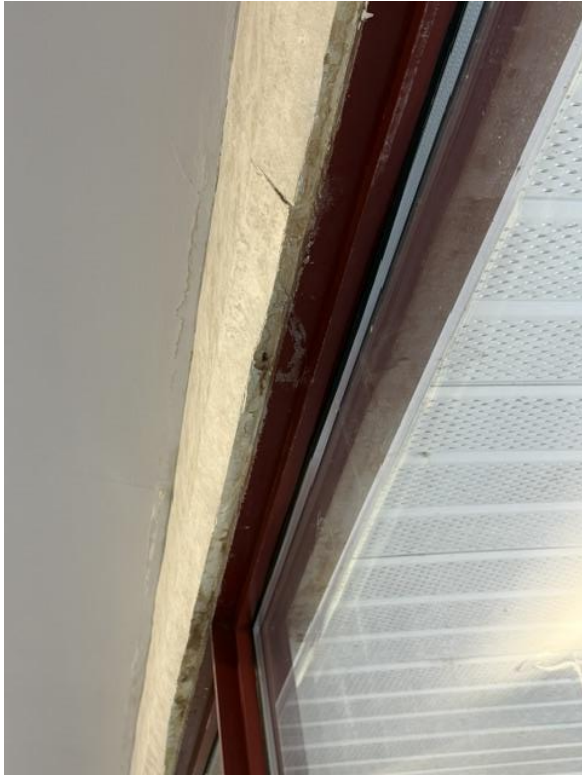
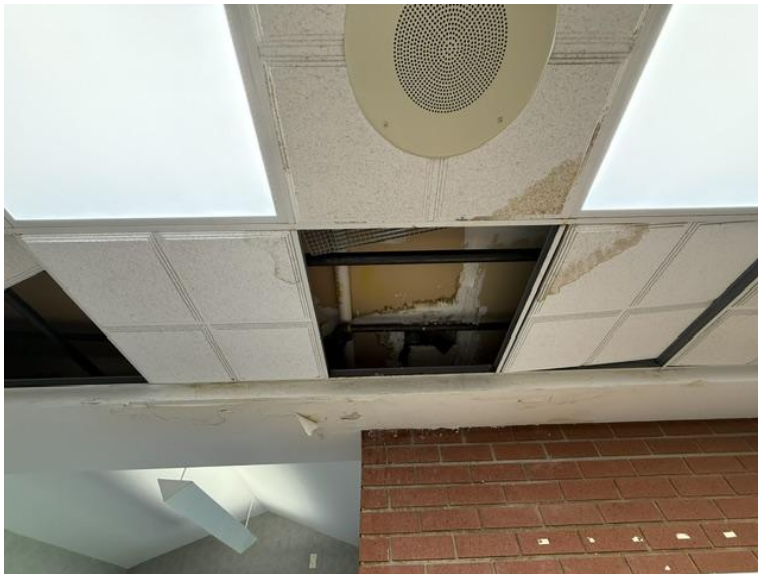
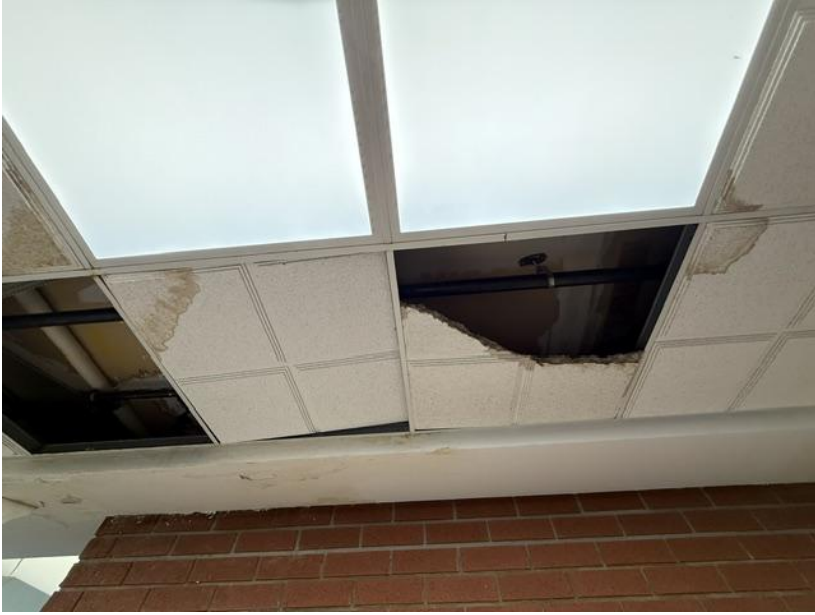
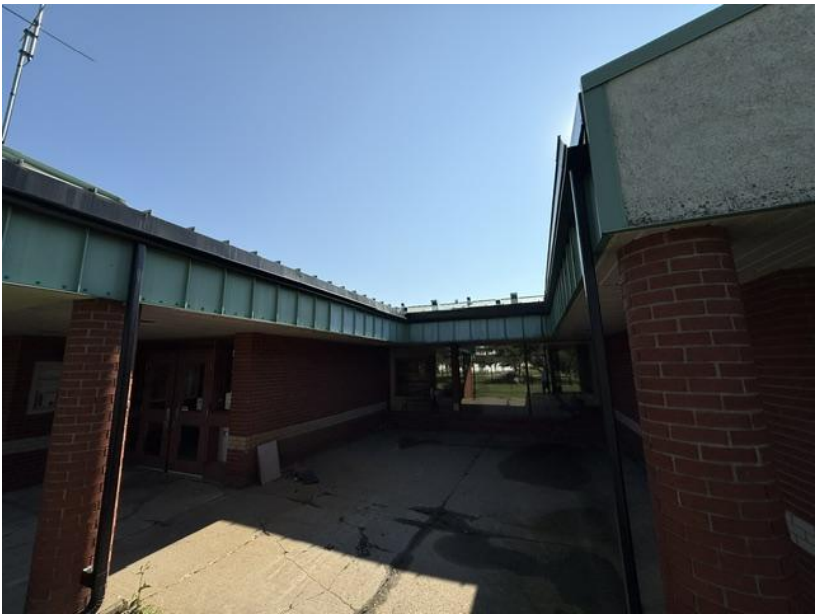
Link between Daycare and Village office, west hallway. Damage due to ice damming:

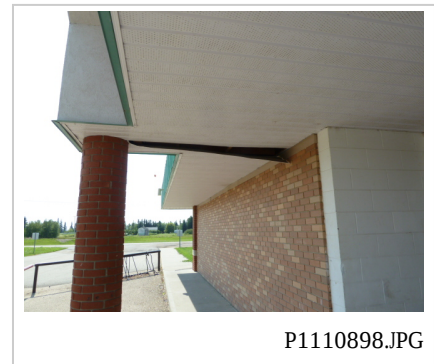
P1110898.JPG

(1964) Addition (East Corridor Exit) - has damaged metal soffit.

| Line Item | Quantity | Unit Cost | Units |
|---|---|---|---|
| Repair prefinished metal soffits. 2 linear metres) | 2 | \$580.46 | lm |
